INDOOR AIR QUALITY ASSESSMENT

Sewage Backup Investigation

**Department of Children and Families
151 West Boylston Street
Worcester, Massachusetts**

Prepared by:
Massachusetts Department of Public Health
Bureau of Environmental Health
Indoor Air Quality Program
February 2018

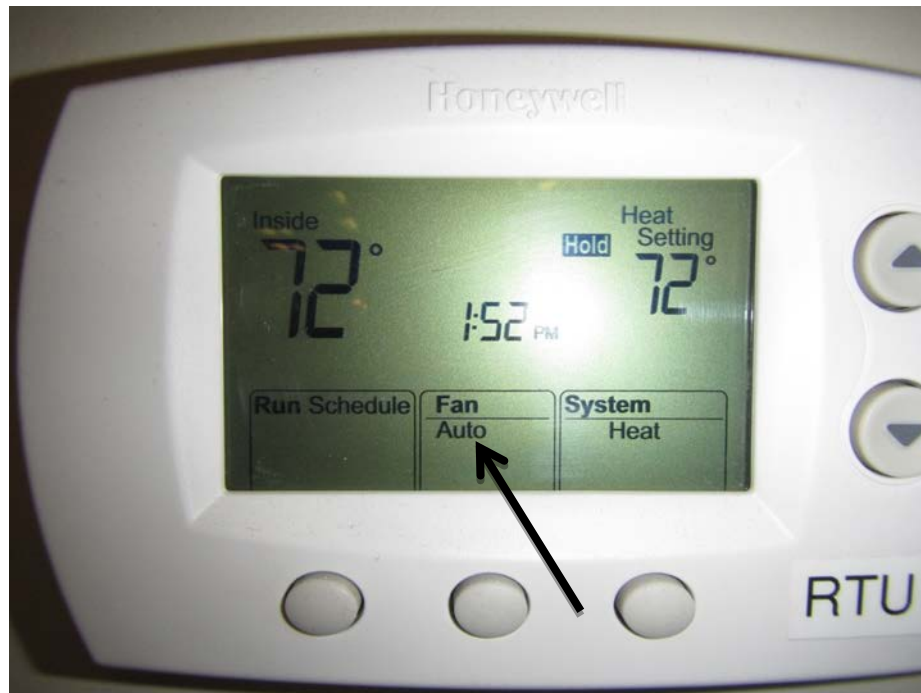
Picture 1

Many areas assessed had elevated carbon dioxide levels. This is likely due to the fact that all thermostats observed were set on the fan “auto” setting (Picture 1). MDPH recommends these thermostats remain on the fan “on” setting during occupied hours. This is especially important in buildings where there are no openable windows such as in this DCF space. Some occupants may express discomfort with drafts if they are seated directly in the flow of the supply air diffusers. In these cases, either the occupant desk location or the location and direction of the vent should be adjusted rather than limiting the air supply.

Thermostat showing fan set to “auto” rather than recommended “on” setting

13. Set all thermostats to fan “on” to provide for continuous fresh air exchange during occupied hours. Consider locking these thermostats to prevent tampering. Change supply diffusers (or desk orientation) to direct air flow away from occupants who express discomfort with direct/constant air flow.

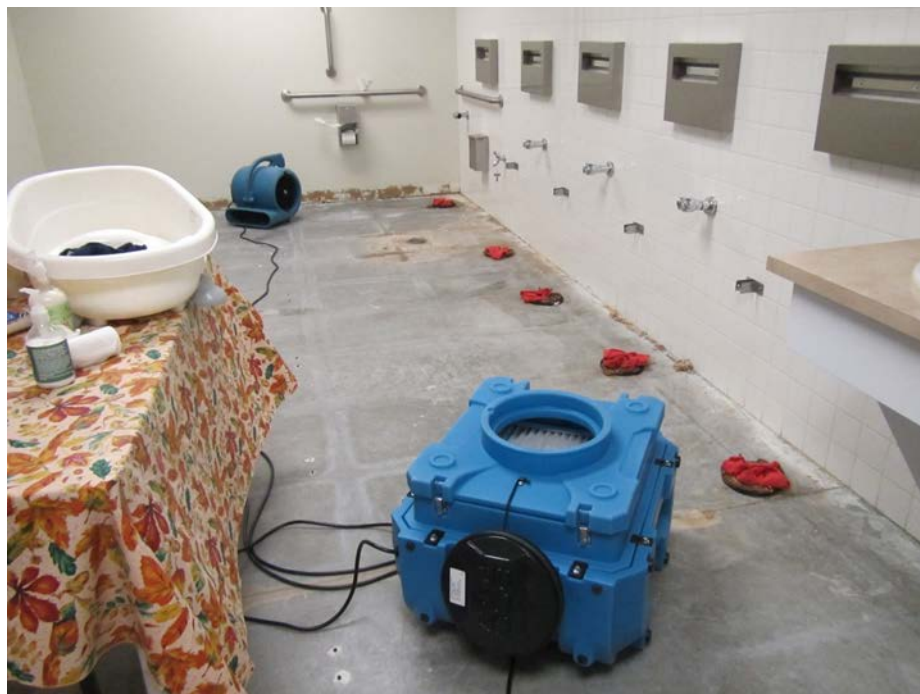
Picture 2

Fan and HEPA scrubber being used during the remediation effort

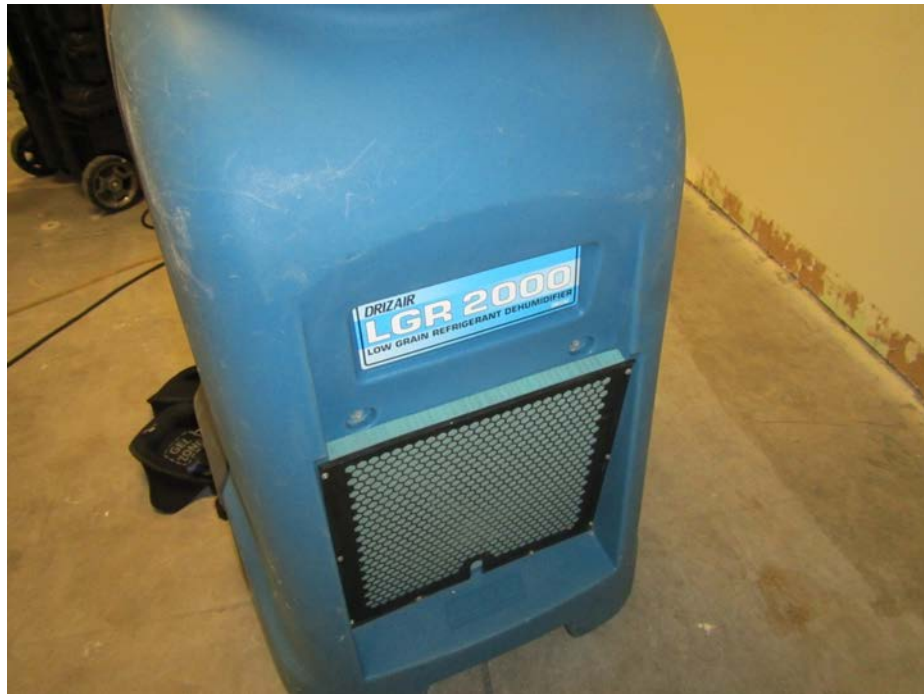
Picture 3

Dehumidifier used during the remediation effort

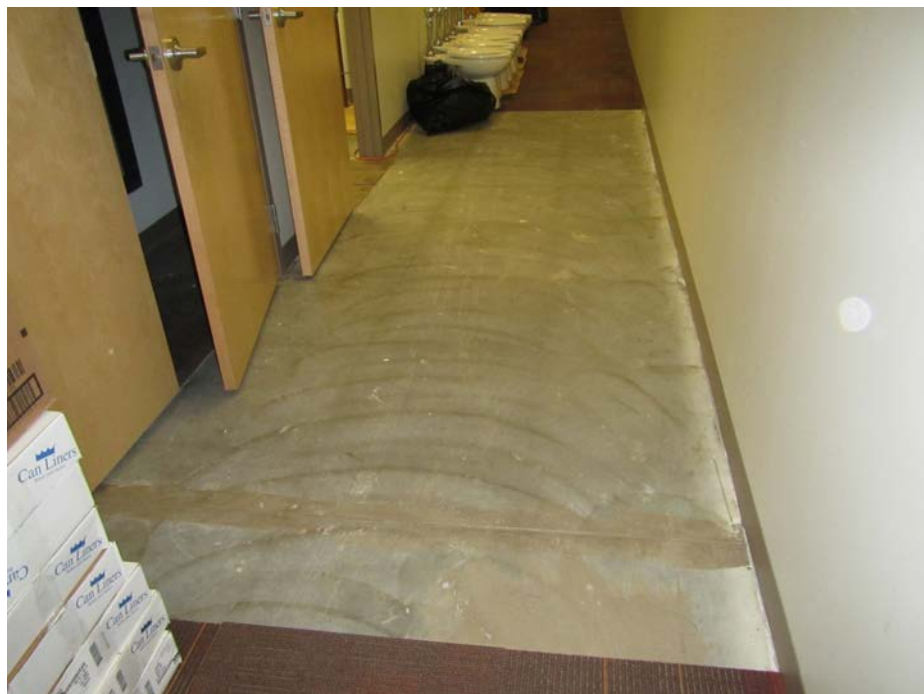
Picture 4

IAQ staff noted that the remediation contractor removed the baseboard coving and flooring tiles in affected areas (Pictures 4 and 5) and planned to remove the gypsum wallboard (GW) from the janitor closet where the sewer ejector pump chamber is located (Picture 6). It was reported by the contractor that the sewage water (i.e., blackwater) did not rise high enough to wet the GW in the restrooms and other walls surrounding the restrooms due to a half inch gap beneath the GW and floor drains in the restrooms intercepting the effluent. However, during the assessment DCF staff revealed pictures that showed many of these areas were in fact impacted by the blackwater. Using a moisture meter, IAQ staff and the contractor tested these GW walls for moisture and found that they were still wet even four days after the sewage backup (Pictures 7 through 9).

Carpet tiles removed in hall near janitor closet

2. Ensure that all porous items and building materials (e.g., carpet tiles, GW, papers) that were damaged by the backup of blackwater are removed and discarded. This would include wallboard behind tiles in restrooms if it is deemed porous (GW) and not able to be properly sanitized.

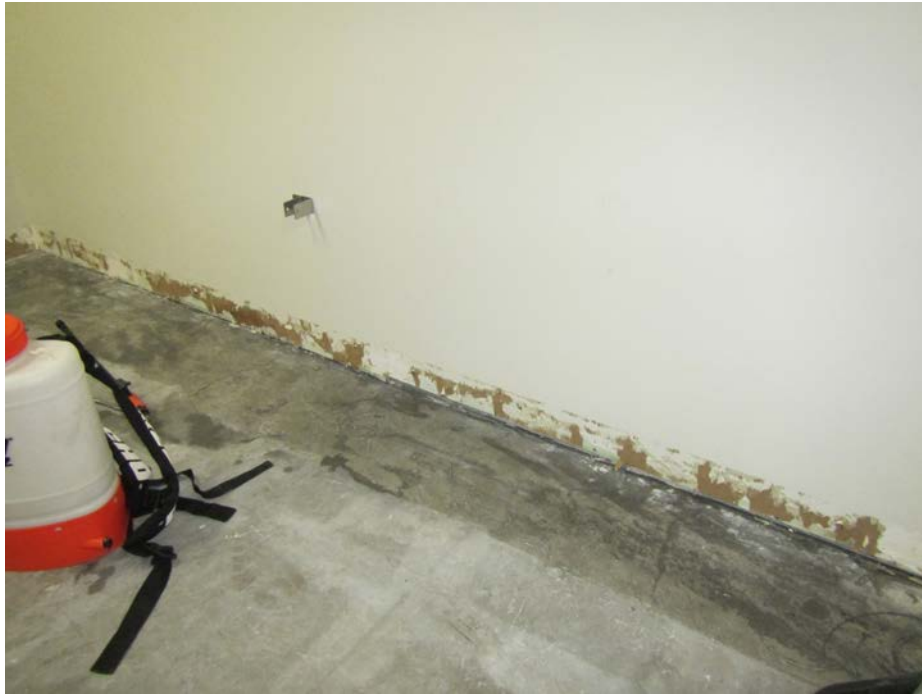
Picture 5

Coving in restroom removed but GW was still in place

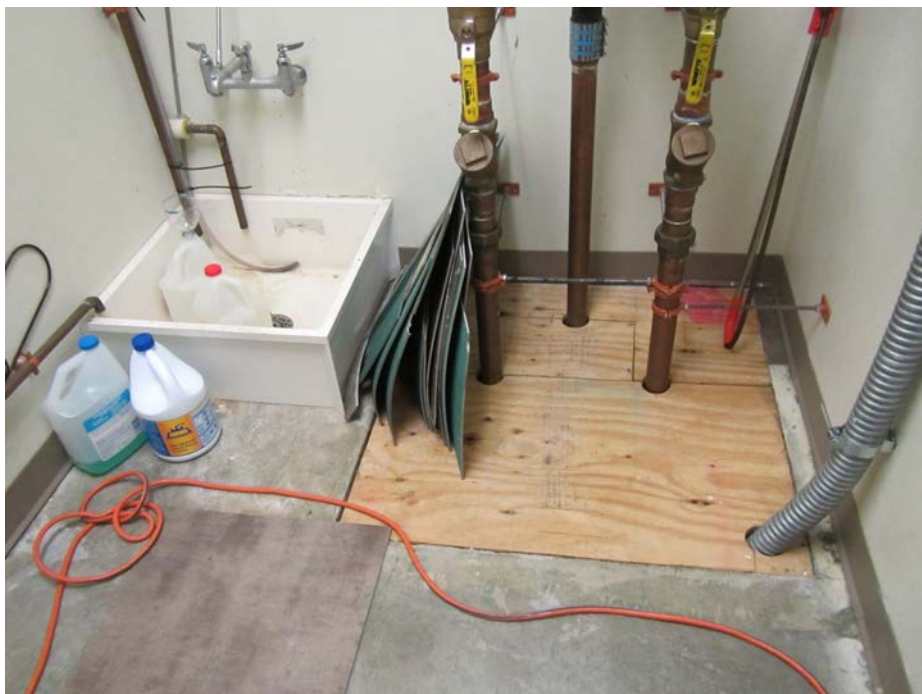
Picture 6

Janitor closet housing sewer ejector pump chamber (GW to be removed)

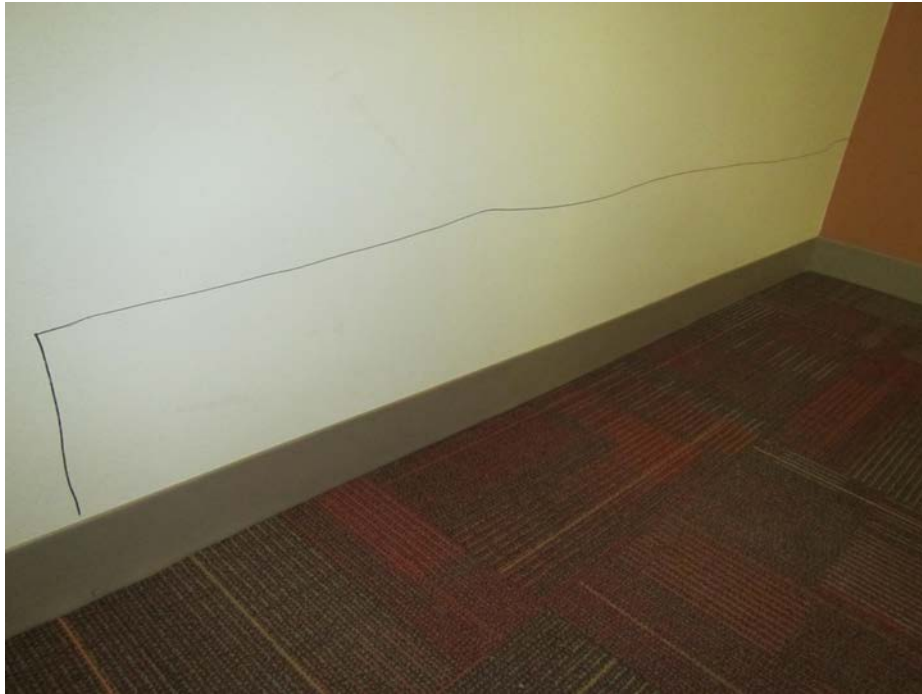
Picture 7

GW behind restrooms found wet during assessment (must be removed)

It is important to note that porous materials (e.g., GW, carpet, cardboard) that have been in contact with blackwater ***cannot*** be effectively cleaned/sanitized or dried and ***must be disposed of*** properly. The contractor agreed at that time that these affected GW walls also needed to be cut out 12 inches above the highest affected area and disposed of properly. IAQ staff also stated that the tile walls in the restroom would need to be cut one foot above the high water mark if the backerboard behind the tile wall is GW (Picture 10). Typically the blackwater permeates the grout between the tiles and may impact any GW behind the nonporous tile. It is very likely that the drains in the bathroom were backing up during the event and unable to receive the blackwater since they lead to the same effluent pump chamber. These drains would only be effective if the clog was at the point of a fixture (e.g., toilet) and not in the pump chamber itself.

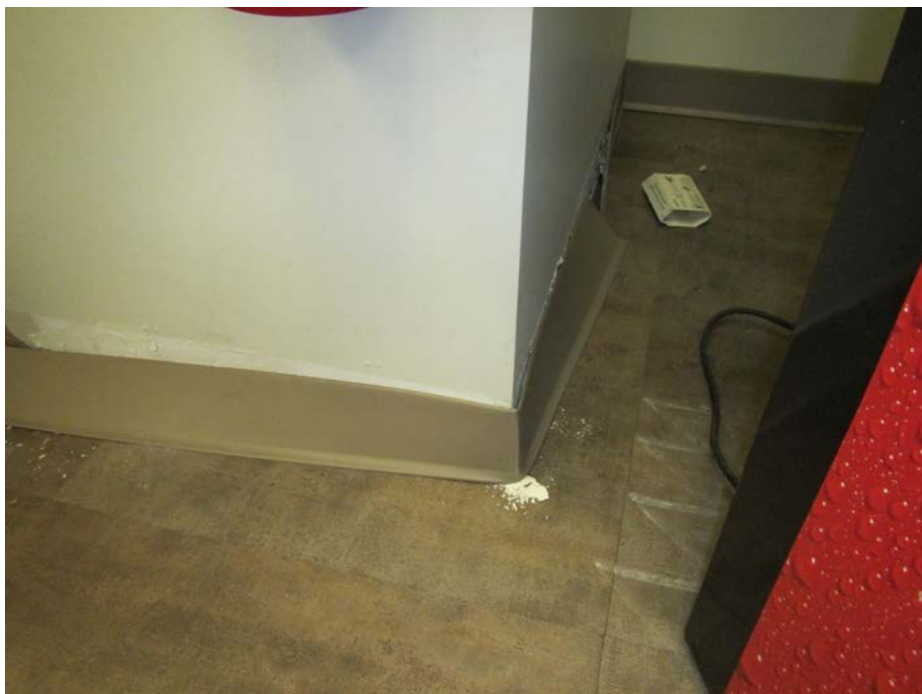
Picture 8

GW behind soda machine in break room found to be wet (must be removed)

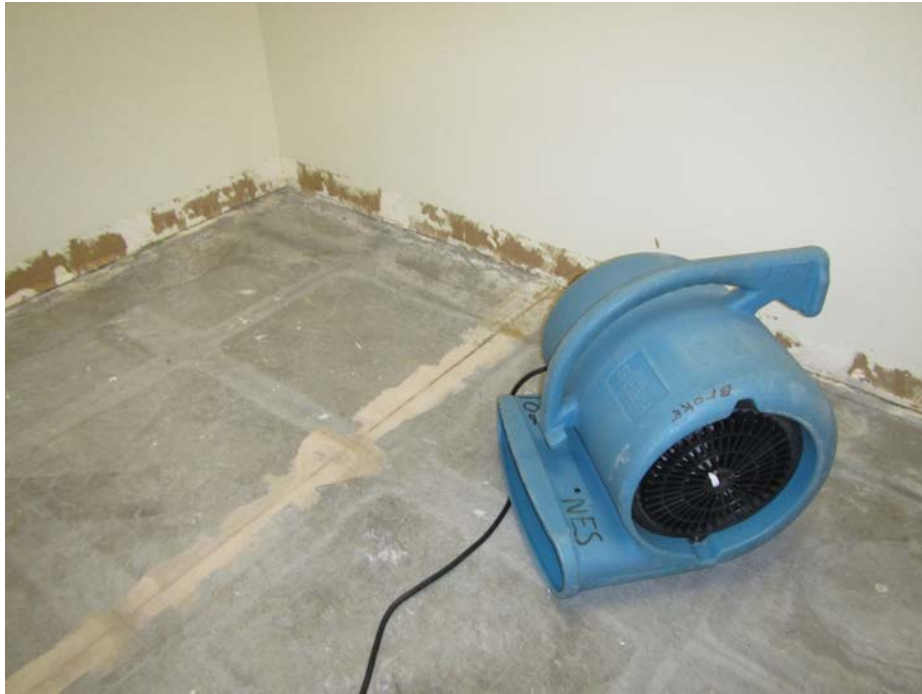
Picture 9

Water-damaged GW in restrooms (must be removed)

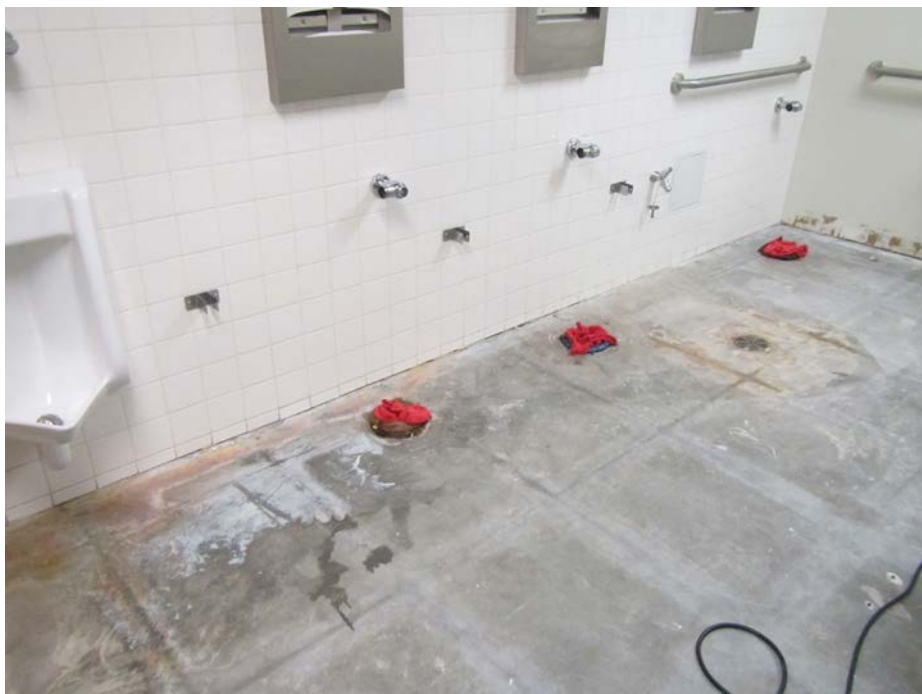
Picture 10

Affected tile walls should be cut 12" above high water mark if GW is backer material

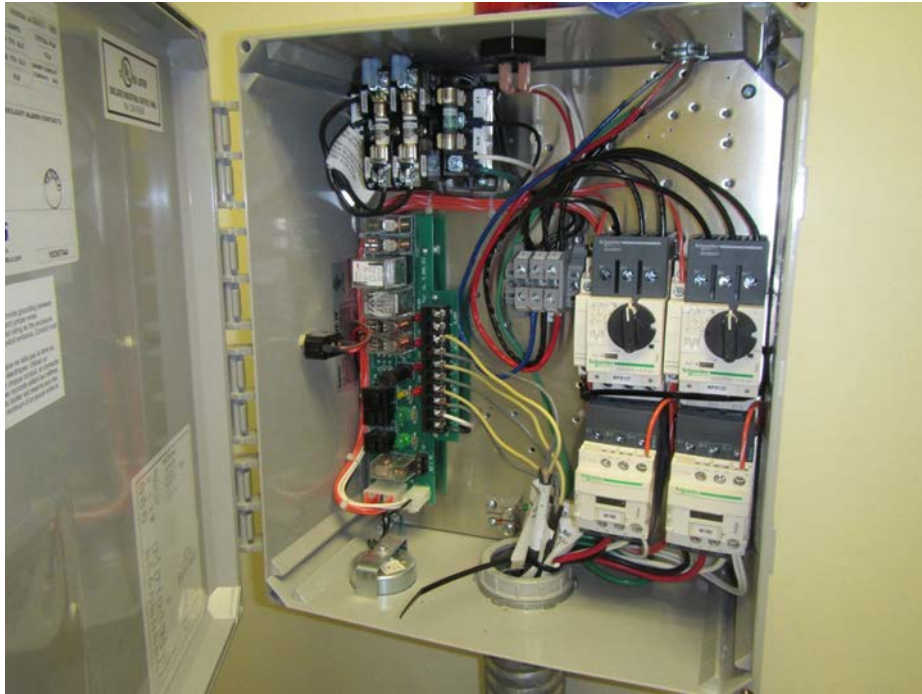
Picture 11

Property management representatives reported that the sewer ejector pump in the DCF space had tripped the circuit due to blockages around the pumps in the pump chamber. It was

further reported that this situation has occurred multiple times in the past 4 years. DCF staff reported that the high water alarm in the pump chamber never sounded prior to the sewer backup but the pumps were very loud before tripping the circuit. It is possible that the pumps and alarm share the same circuit rather than separate circuits as required (Picture 11) or that the float switch in the pump chamber is not functioning properly. In either case, the high water alarm is essentially disabled and ineffective. Further, the pump chamber capacity is a very important consideration. Due to the large building population, the emergency storage capacity of the pump chamber should be inspected so that if the alarm sounds, there should be ample storage volume in the event of system failure. This ejector pump chamber is the sole means of removing sewage from the DCF space since the effluent needs to be pumped up to the street in the current building sewer configuration. When this setup fails, the DCF office is essentially left without working plumbing.

Pumps and alarm should be on separate circuits back to main electric panel

5. Have the building sewer line inspected out to the city sewer line at the street to find any clogs or breaks in the line.
6. Have an electrician confirm if the high water alarm float is wired/operating properly. Also ensure that the pumps and the alarm are all on separate circuits back to the main electrical panel so that one tripped circuit does not disable the alternate pump or the high water alarm.

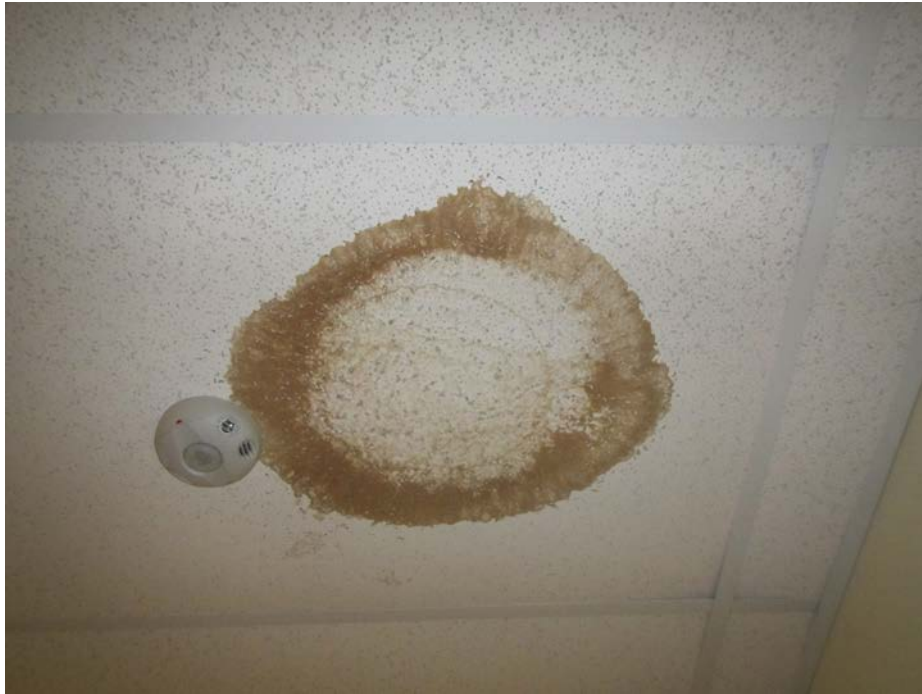
Picture 13

Water-damaged ceiling tiles were observed in some areas (Picture 13; Table 1). Some of these stains may be from historic leaks while others were reportedly due to active roof leaks reported by occupants.

Water-damaged ceiling tile

11. Fix roof leaks and replace water-damaged ceiling tiles.
12. Inspect the building envelope for gaps/cracks in brickwork and problems with flashing. Seal these openings to prevent the infiltration of moisture into occupied spaces.

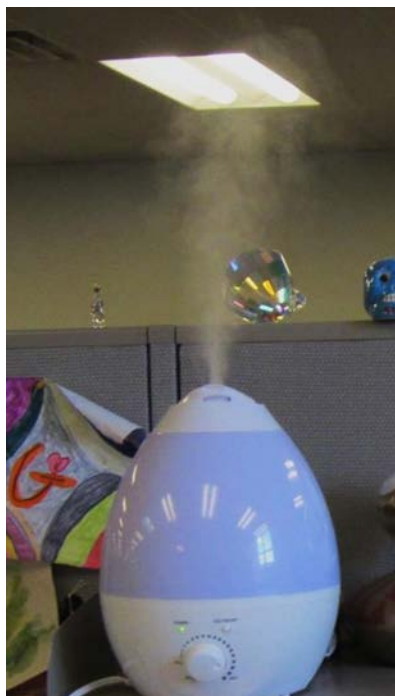
Picture 14

IAQ staff noted a few areas with personal humidifiers (Picture 14). Although the winter heating season is very dry, these devices are not typically recommended in offices. The water vapor represents a moisture concern since it will condense on surfaces below the dew point temperature and may wet porous building materials. Also, if they are not cleaned regularly according to manufacturer recommendations, these devices may serve as a source of odors and microbial contamination.

Humidifier in office area

17. Reduce or eliminate the use of products containing VOCs (e.g., air fresheners, scented cleaning products, and hand sanitizer).
18. Discontinue the use of all humidifiers in the space to reduce the possibility of condensation or microbial colonization. Do not use fragrances in humidifiers.

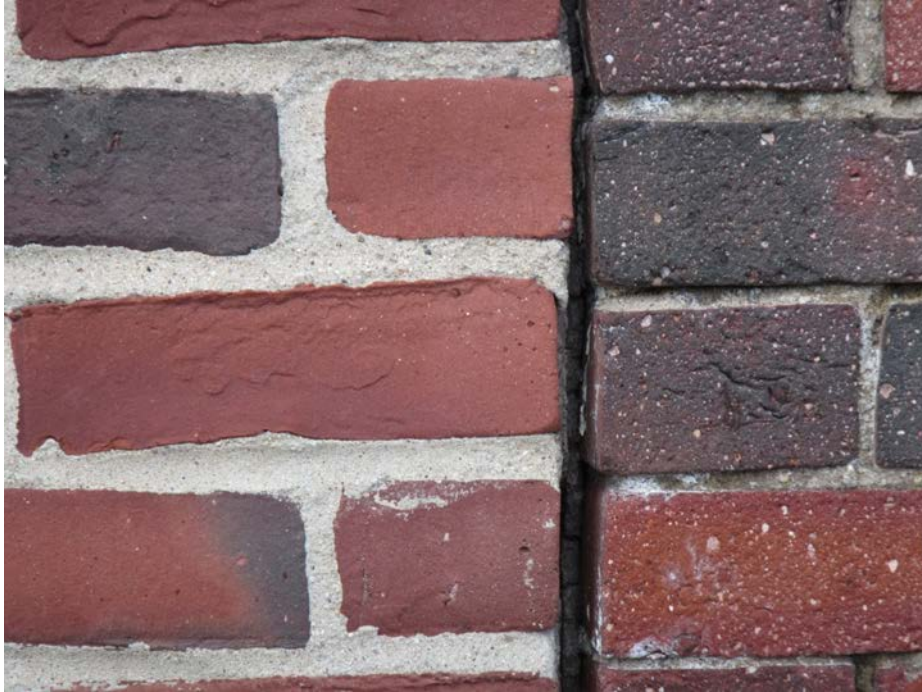
Picture 15

During the building envelope inspection, IAQ staff noted many gaps in the brickwork which may allow water infiltration into occupied spaces (Pictures 15 and 16). A number of occupants expressed concerns regarding active leaks especially those situated along the front of the building (Pictures 17 and 18).

Large gaps in brickwork

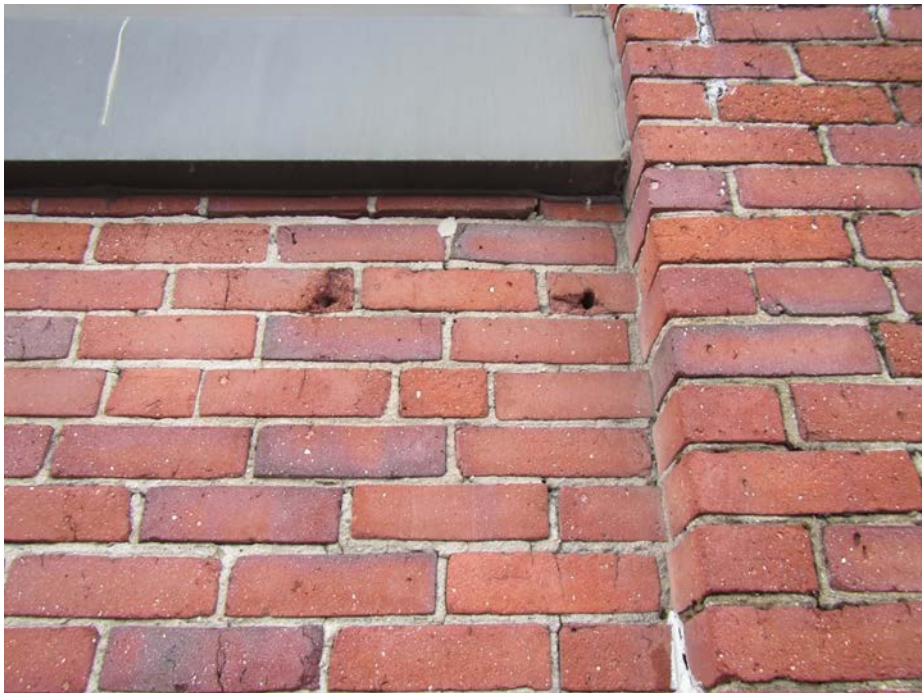
Picture 16

Holes/gaps in brickwork beneath window

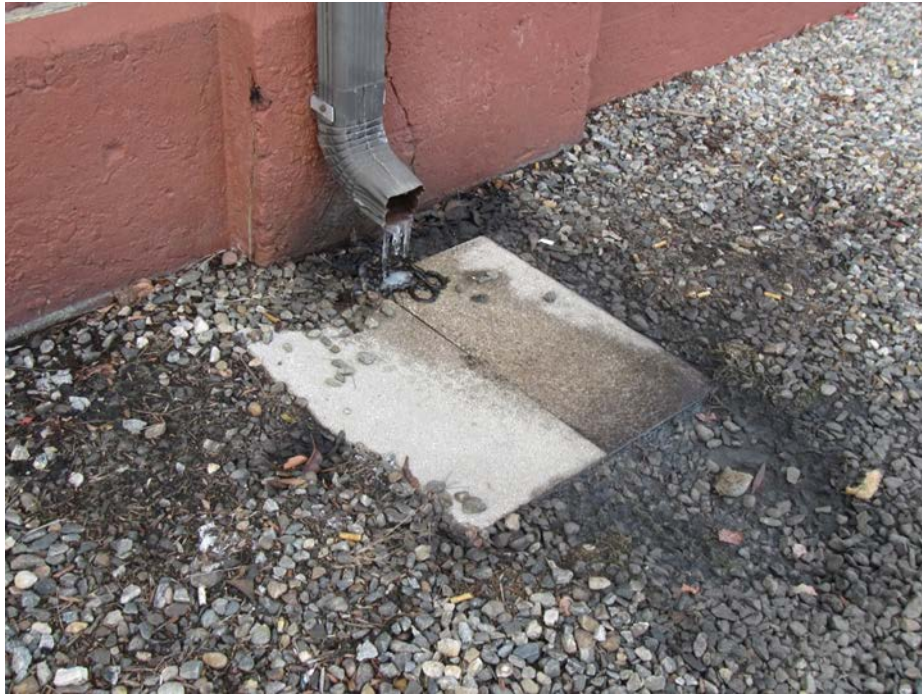
Picture 17

Gutter draining in close proximity to the foundation

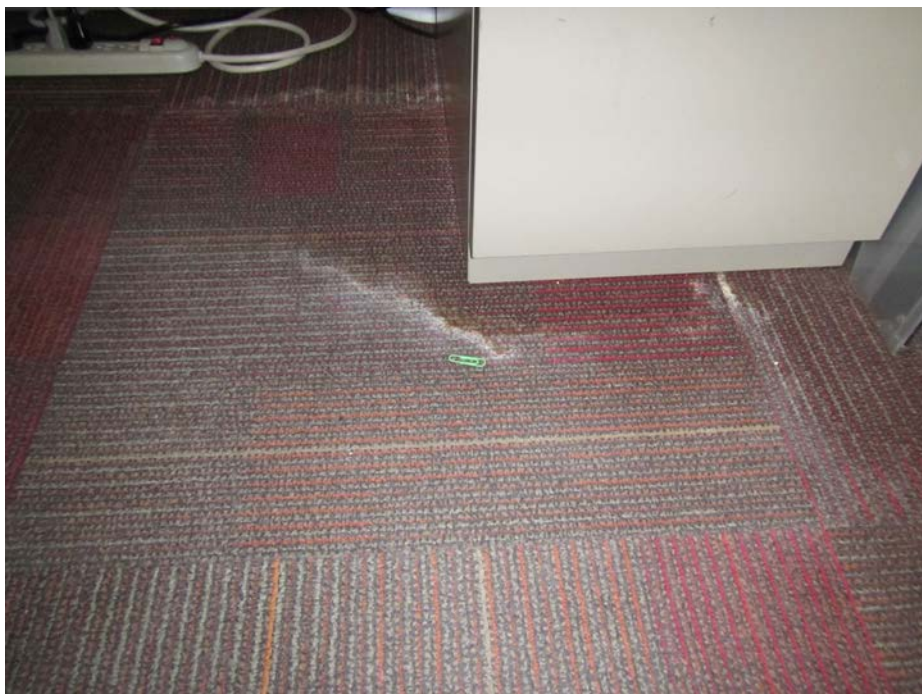
Picture 18

Water-damaged carpet due to infiltration from front of building

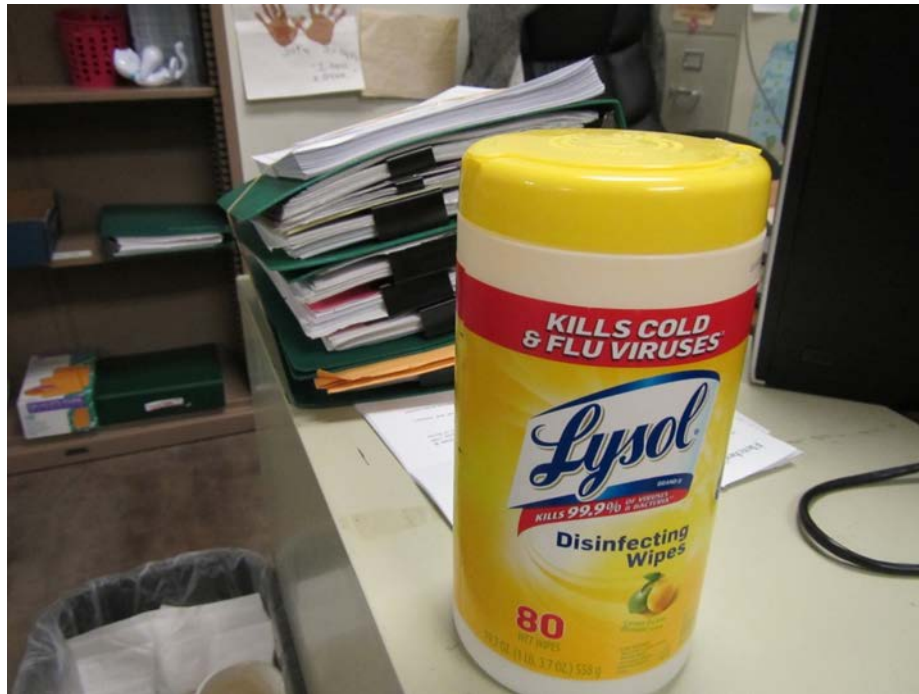
Picture 19

IAQ staff noted several areas with air fresheners, scented cleaning products, and hand sanitizers (Picture 19; Table 1). These products contain volatile organic compounds (VOCs) and other fragrances which may cause irritation of the eyes, nose, and respiratory system. Note that the humidifier shown in Picture 14 was also dispensing a fragrance. The only measureable TVOCs during the assessment were in the vicinity of this device and the PM2.5 results in this area were also much higher than elsewhere.

Scented cleaning products (contain VOCs) in use at the office
